Fora Half A Bearing Failing – An Investigation into Causes Buzz Wilson Buzzwilson44@gmail.com

Introduction

This is the first of what I hope to be a series of articles on improving Half A engine performance. The motivation for this first article is bearing failures in the Fora Half A engines.

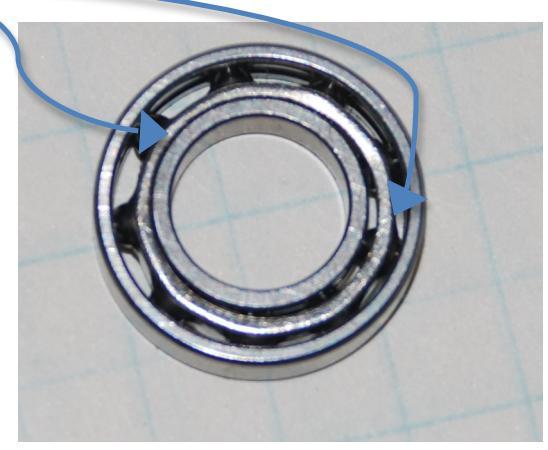
For the past two seasons I have experienced an issue with rear bearings in the Fora Half A engines. Take a close look at the photo and you will see an uneven wear pattern on the retainer ring.

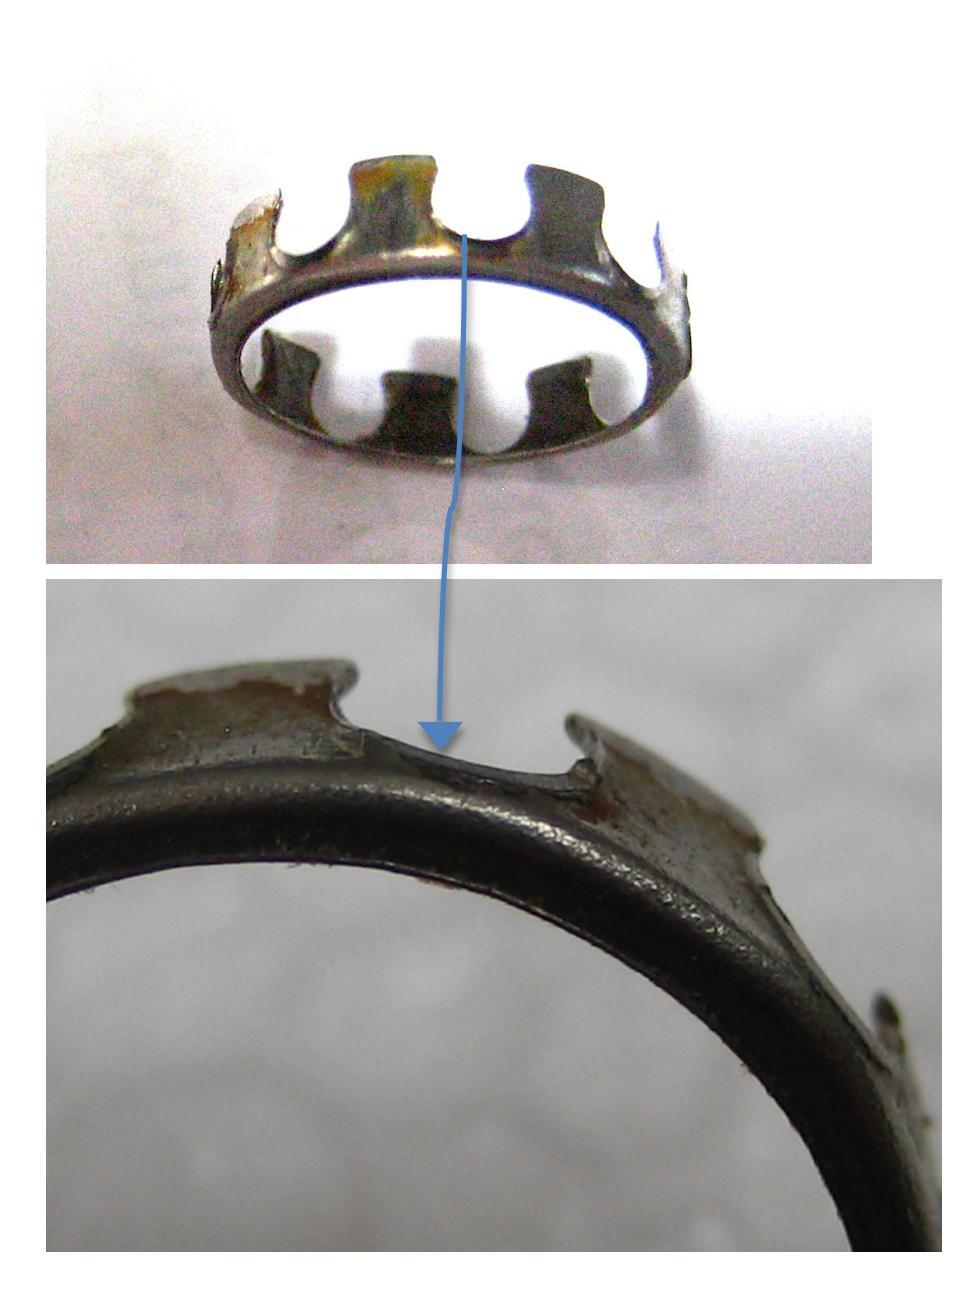
The Fora bearing only captures the balls on one side of the retainer whereas the Cyclon bearing captures both sides of the balls. The Fora bearing retainer is called a "W" type. The cage snaps in from one side over the balls and is usually not used in high-speed applications. *We have high speeds.*

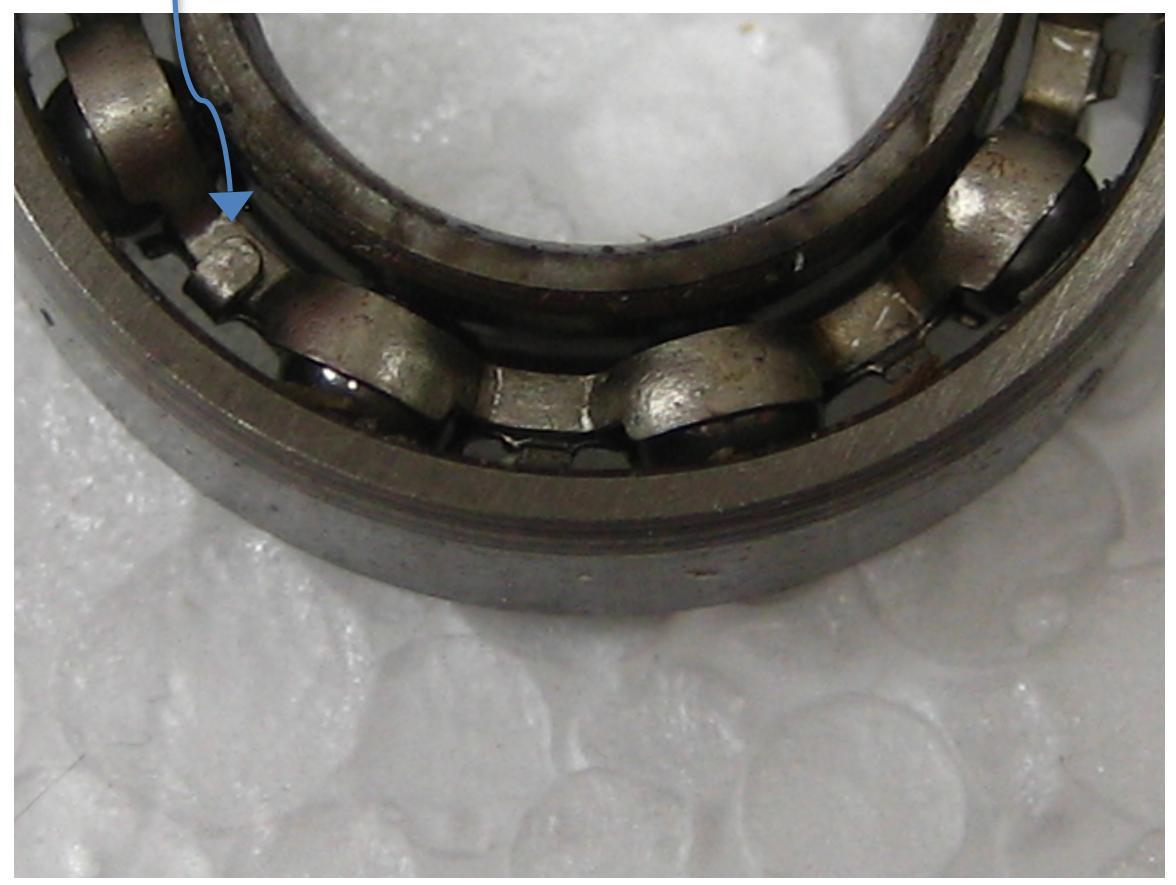
The Cyclon bearing uses a "J" type where a two-piece ribbon consisting of two halves are assembled one half from one side and the other half from the opposite side. Fold down tabs secure the two halves. Here is a photo showing the fold down tabs.

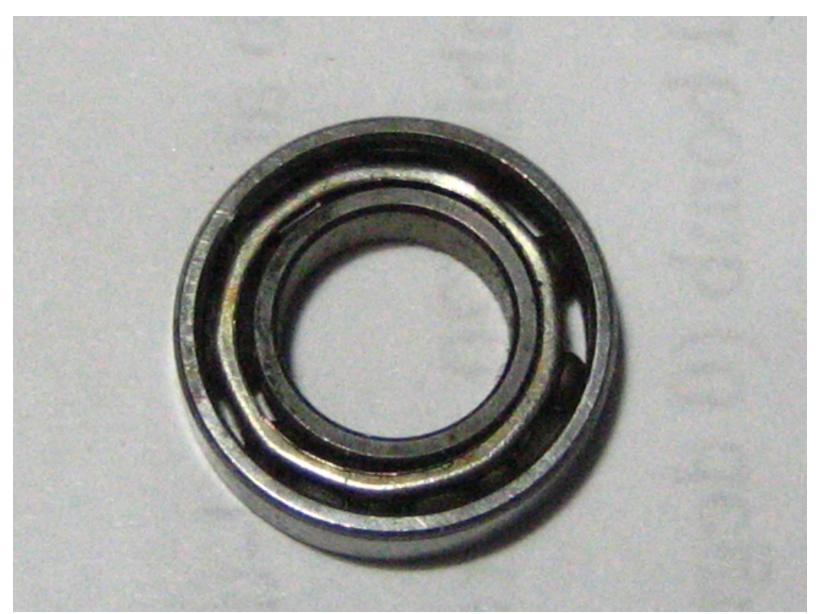
You will notice on the retainer ring low points and high points. The high point occurs at the ball. The retainer ring has an opening to capture each ball. The first thought to come to mind is there is an up force being applied that is resisted by the ball but not by the gap between the balls thus causing the difference. Glass half full. There could be a down force being resisted by the ball but not by the space between the balls. Glass half empty.

When viewed from this side it appears that the inner race is not centered. Since the balls ride between the inner race and the outer race for this to happen the balls would have to significantly deform. I have noticed some flattening but nothing to shift the inner race. I have measured the inner and outer race and established that the inner race is centered. There are nine balls in the bearing. When I rotate the inner race, I can get the retainer to contact the inner race at four of the ball positions. In other words 44% of the retainer is contacting the inner race way. The first bearing that failed had 66% contact.

What you are seeing is the deformation of the retainer. If you look carefully you will see the retainer contacting the inner race.

Let me begin by saying that a sophisticated lab filled with expensive equipment would be nice to have; I do not think it would invalidate the results. To answer the question of the crank pin I replaced the bearings in three of the Foras. One Fora got a used Cyclon "J" bearing and the other two new "J" type cage bearings

(Boca Bearing MR689(X)). The retainers are steel. I have taken these apart and there is no damage to the any of the cages. From these test there have been no con rod failures and therefore the crank connecting pin is not an issue.

Regardless of the cause, the bearings are failing and need to be replaced. Yaro has found affordable replacement bearings with nylon retainers. These and are available from www.aerohobby.ca
